# Navajo Abandoned Uranium Mine

## Site Screen Report

**Mine Name: Charles Huskon No. 7 (MP-357)**  
**Mine ID: 172**

**August 2011**

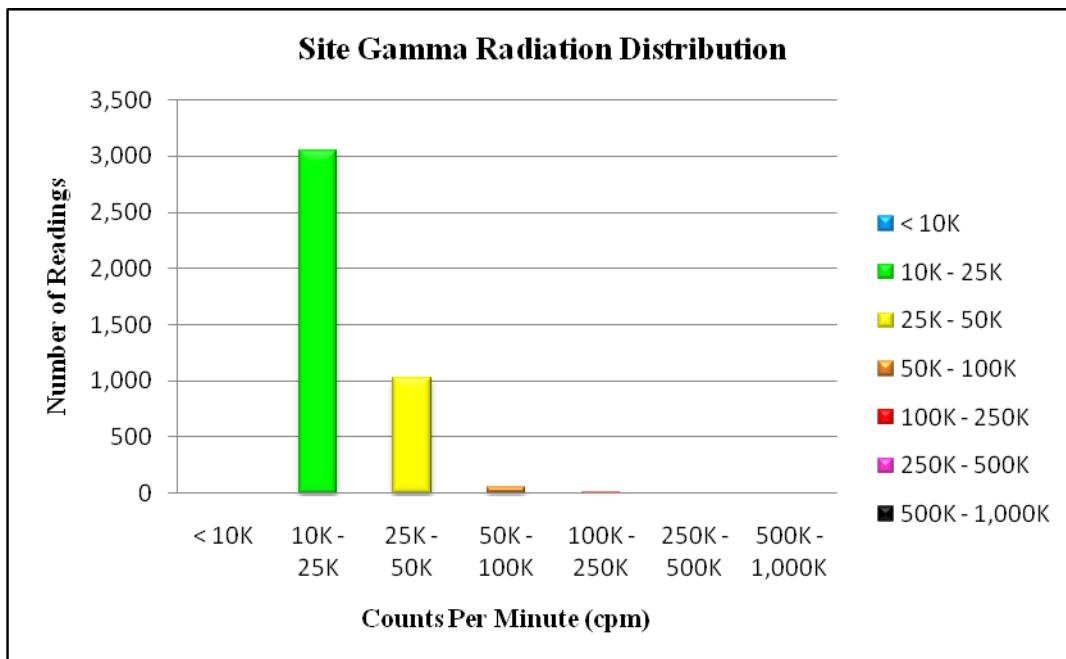
**Highest gamma radiation measurement:** 105,814 counts per minute (cpm)

**Background Average:** 18,044 cpm        **Two Times Background:** 36,088 cpm

A total of 4,140 gamma radiation measurements were collected from the mine site, ranging from 11,923 cpm to 105,814 cpm. Measurements collected in the vicinity of the reclamation areas were found at a maximum level of approximately 60,000 cpm. The measurements are represented in Figures 1 and 2.
